**Monhegan
Museum of
Art & History**

White Paper

Creating a Sustainable Preservation Environment

Project Director: Jennifer Pye
Monhegan Historical & Cultural Museum Association
February 15, 2019

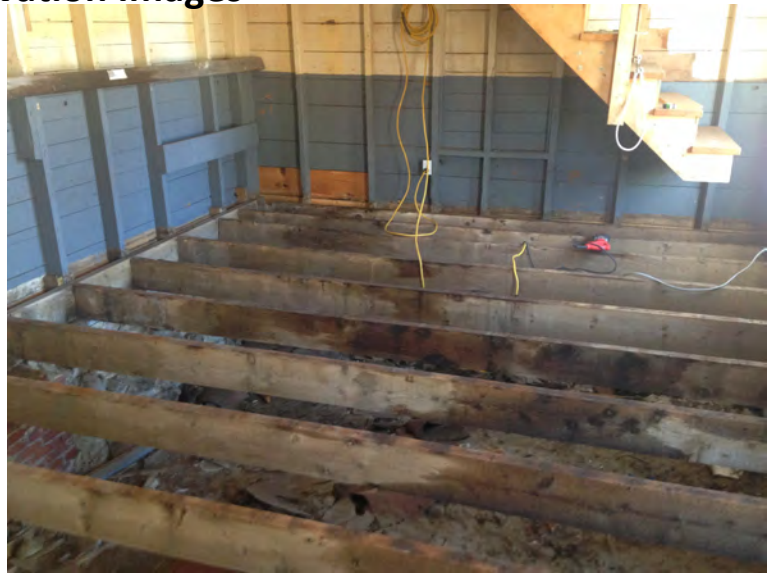
2. After floor removal, soil was removed from beneath building to create space for ductwork.

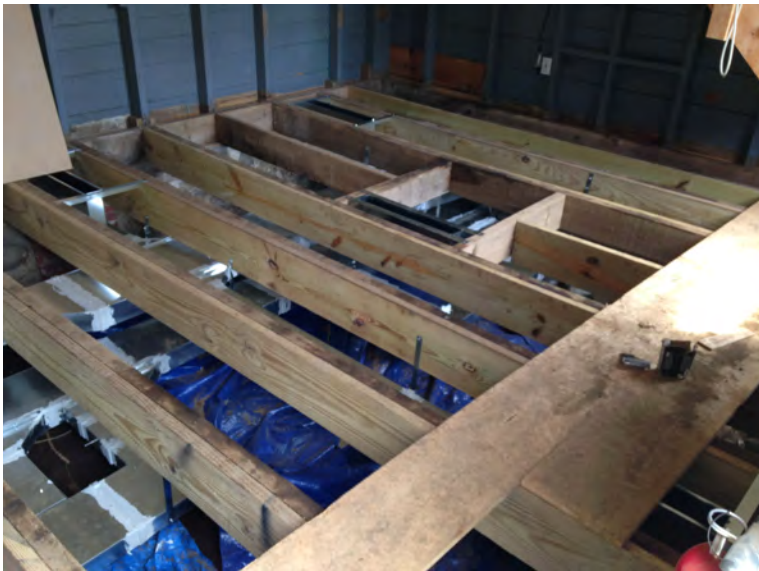
3. Floor joists were reinforced.

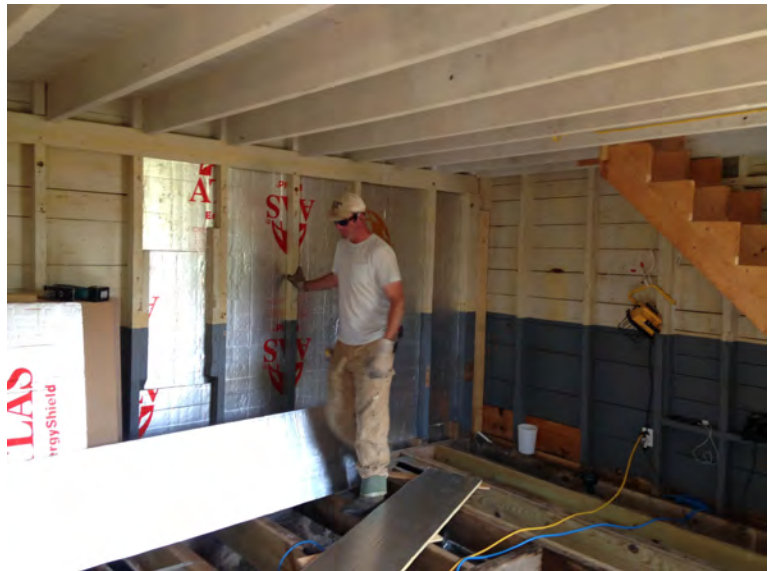
4. Multiple layers of polyisocyanurate insulation were applied between wall joists.

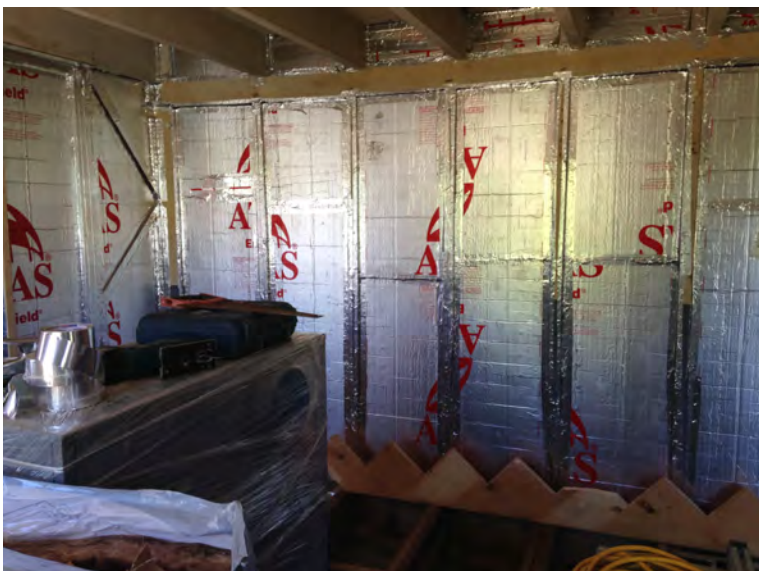
5. Aluminum tape between insulation boards forms a vapor barrier

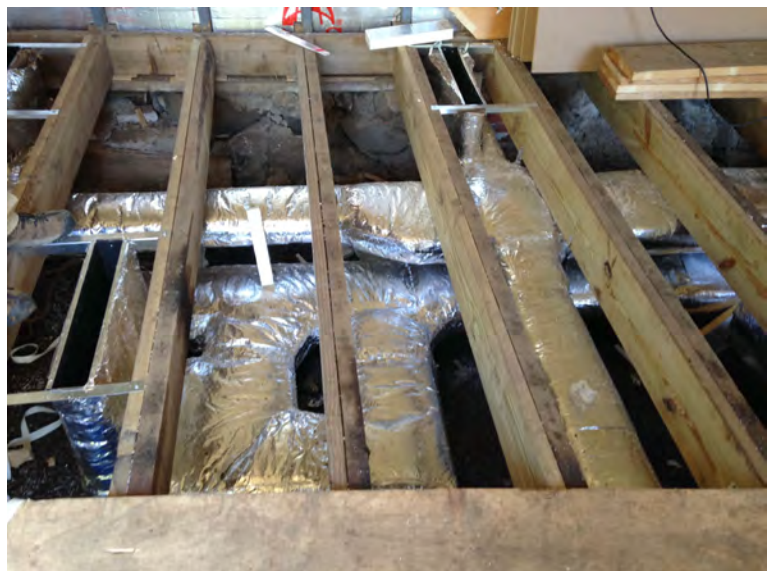
6. Insulated duct work beneath floor.

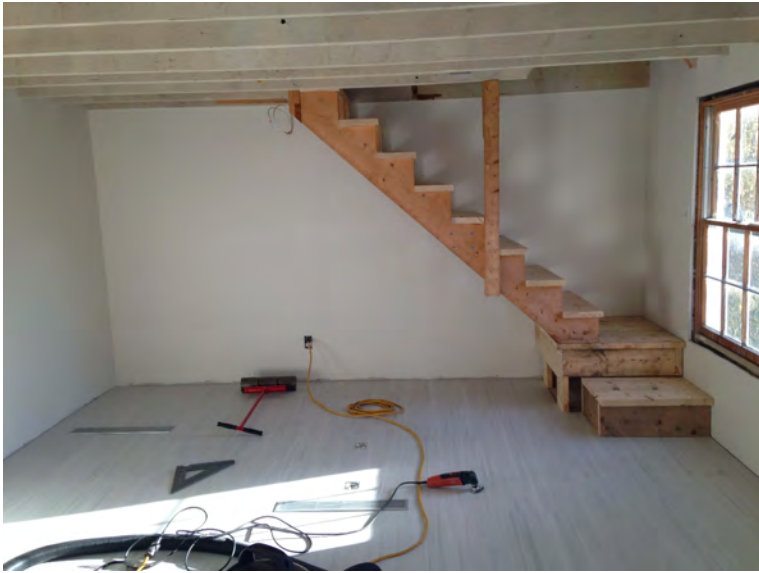
7. Two layers of subfloor, flooring, and sheetrock installed.

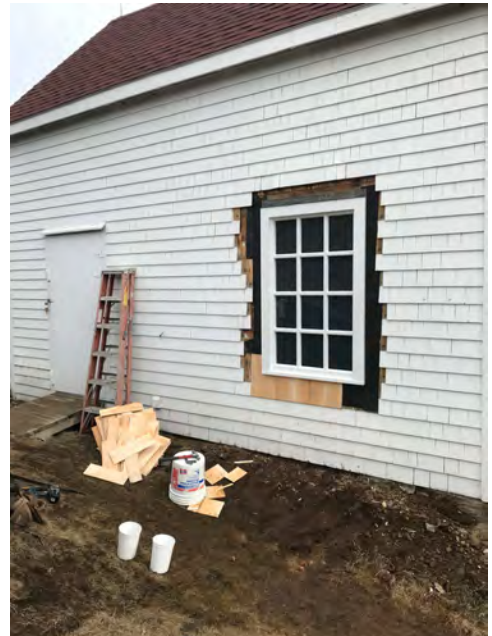
10. Window replaced with a non-opening window for better weather protection. Dark gray plywood and insulation on interior of window.

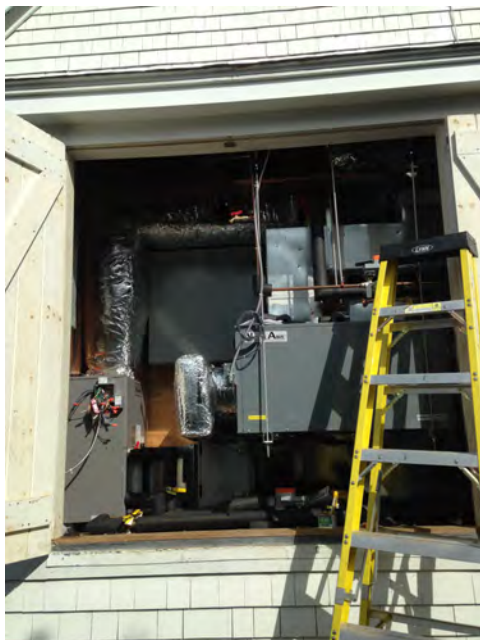
11. Climate control equipment installation in vault mechanical room.

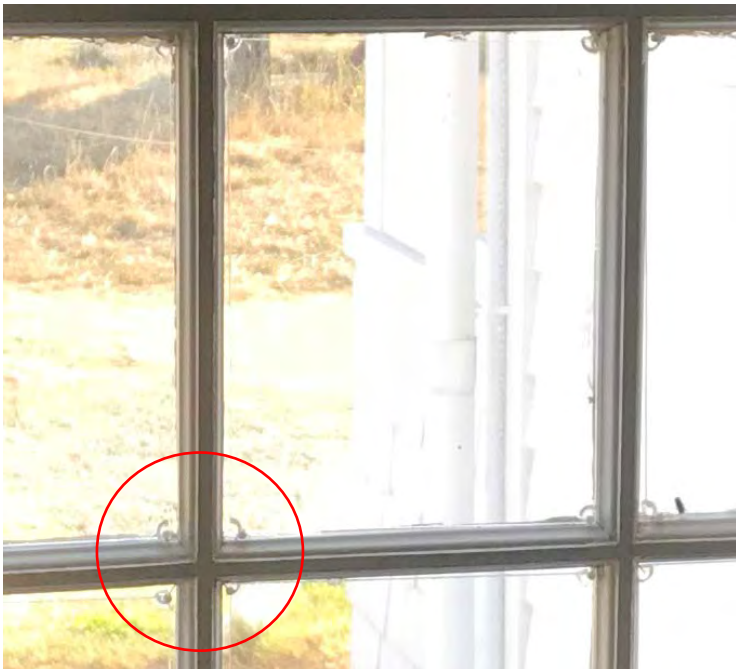
Plexiglas panes held in place by small pins. Air space between the Plexiglas and the glass is created by cutting Bumpons into quarters and sticking them to the edges of the Plexiglas.

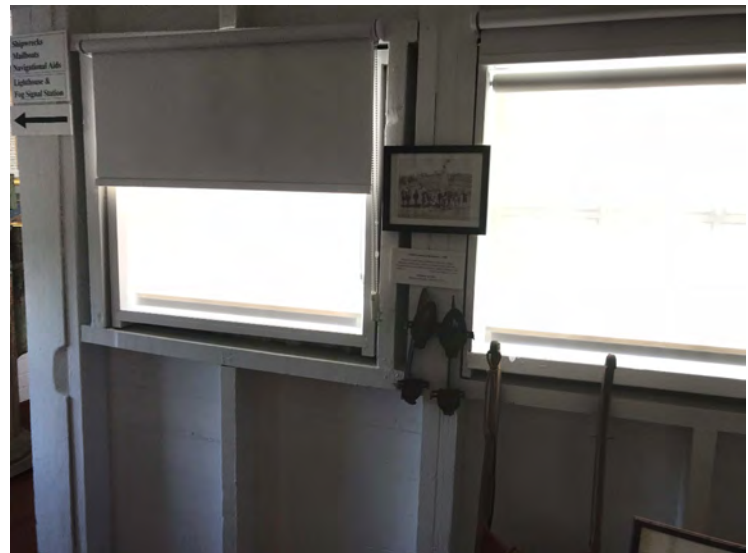
5% open weave light filtering shade is mounted to the interior of the window frame. Light blocking shade mounted to the exterior.

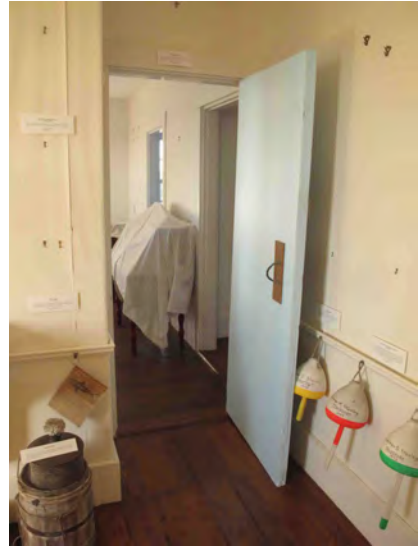
Insulated door panel between the Fishing Room and the History Room.

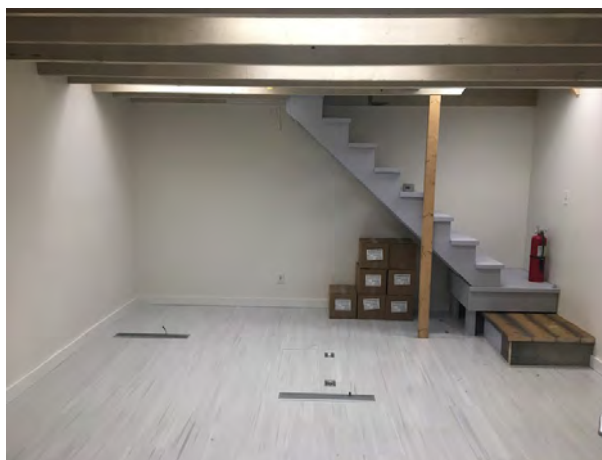
The renovated Ice House first floor - all walls were constructed with additional thermal insulation and a vapor barrier to minimize the energy load on the space.

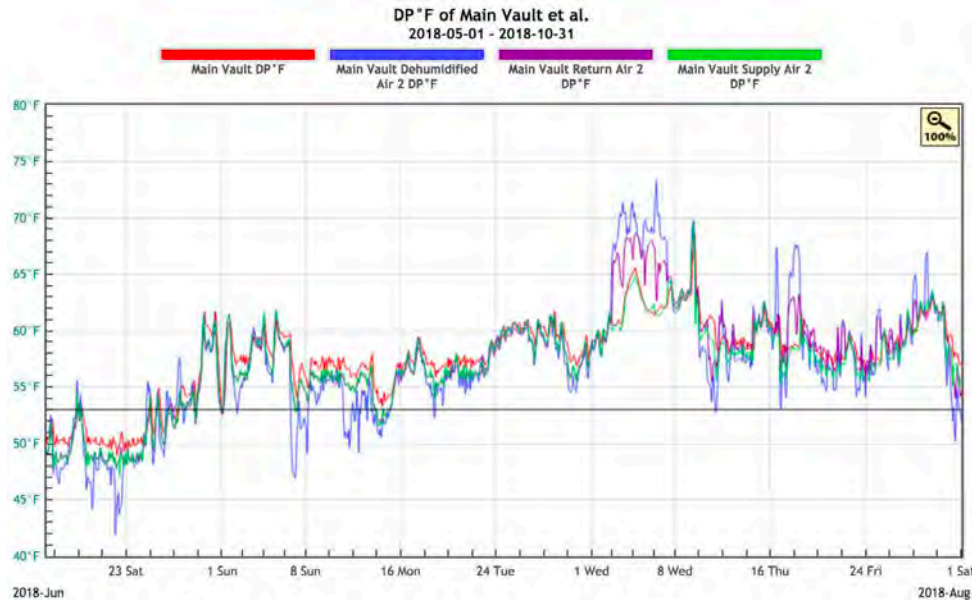
Of greater concern is the fact that the dehumidifier did not seem to be holding the RH limit during the summer season. Using the dew point graphs as a starting point, there is an apparent lack of dehumidification – the difference between the space dew point and the dehumidified air/supply air dew point is typically less than 2F. If dehumidification operation is dictated by RH conditions, the supply dew point is expected to fluctuate somewhat, based on what the space temperature may be. However, in peak summer season, the expectation is that the space temperature will commonly be close to the set point condition, and that the system will have to dehumidify to a particular dew point condition due to the high ambient dew points outdoors. The graph below shows the dew point plots for the Main Vault and the return, supply, and dehumidified air conditions, will all track quite closely. If the RH maximum condition of 55% were being maintained at 70F, the space dew points should track closer to at a 53F dew point condition, represented by the displayed limit line. Even at the current ~75F set point, a max 55% RH condition would result in a 57F dew point condition, still lower than the typical summer operation.

Main Vault, DP Graph - Summer 2018. Note the minimal dehumidification and close tracking of the conditions. If running appropriately, the space dew point (red plot) should track closer to the displayed limit line.

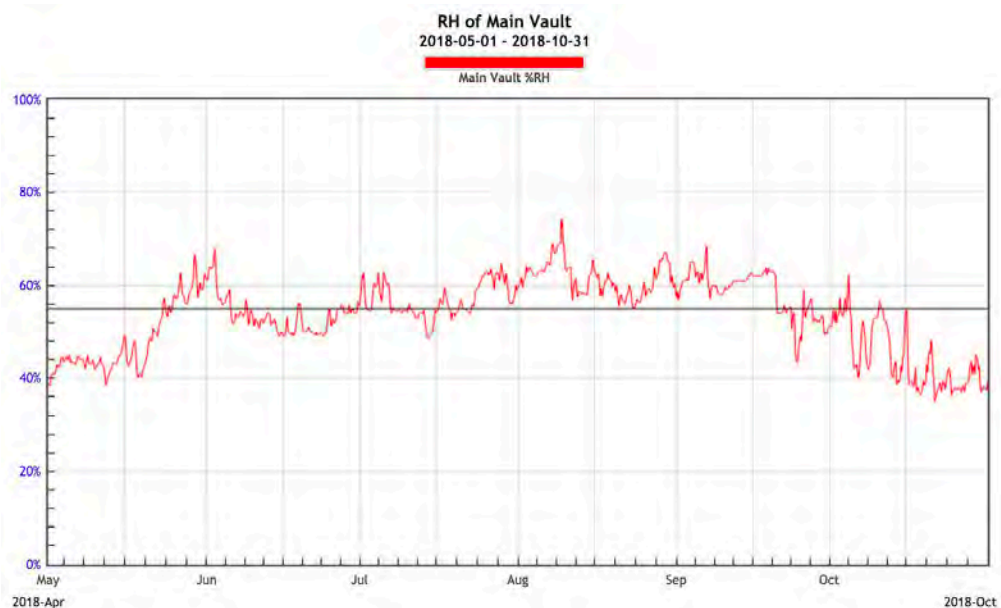
Main Vault, RH Graph - Summer 2018. RH conditions are regularly higher than the 55% max design condition.

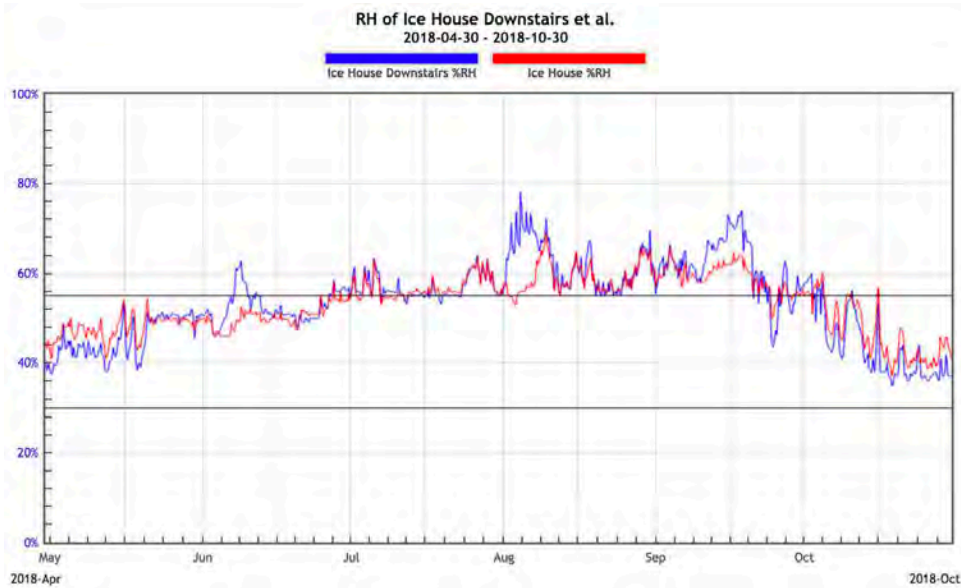
Ice House, RH Graph - Summer 2018. Limit lines are set to 30% and 55%, note RH conditions consistently above 55% for much of the summer.

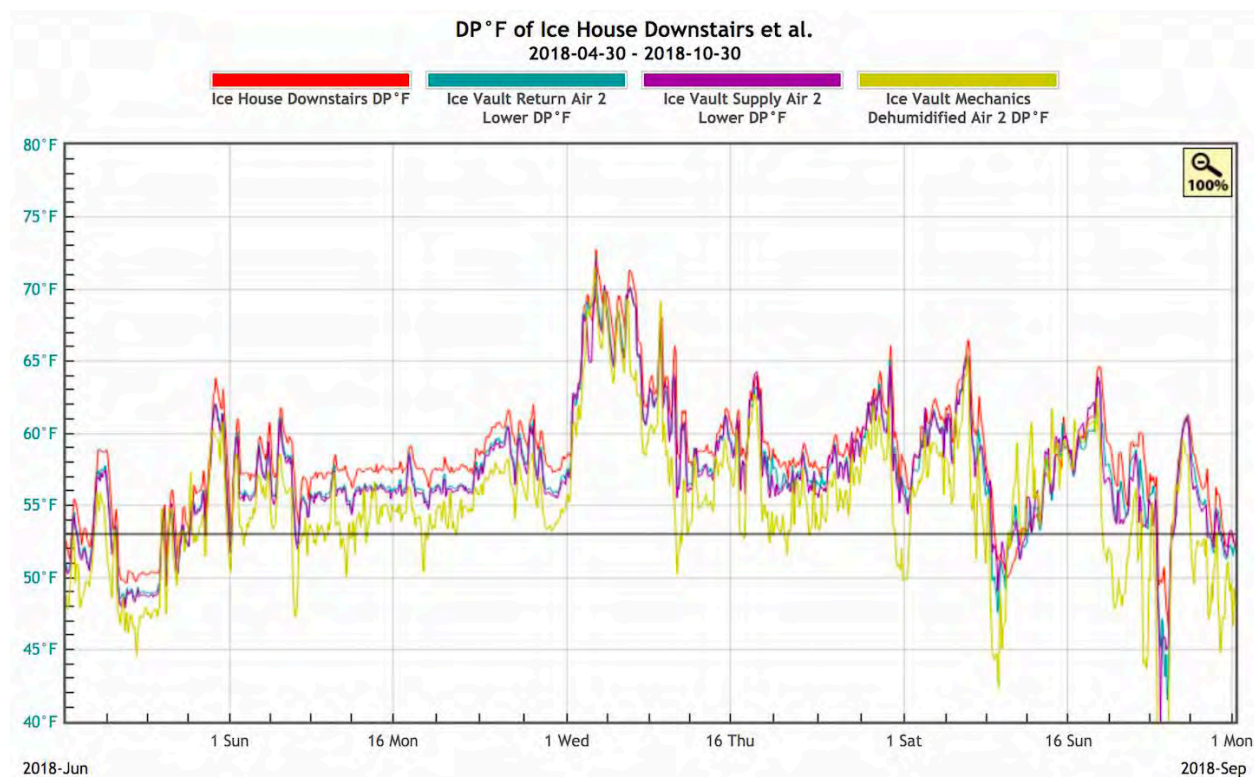
Ice House, DP Graph - Summer 2018. Note that while the dehumidifier is running (yellow plot), the return and supply air dew points track the same.
